Commonwealth of Kentucky
Environmental and Public Protection Cabinet

EMERGENCY AWARENESS BULLETIN

Date: February 17, 2006

EAB-06004 Kentucky Fatality # 3 (National #20) Roof Fall

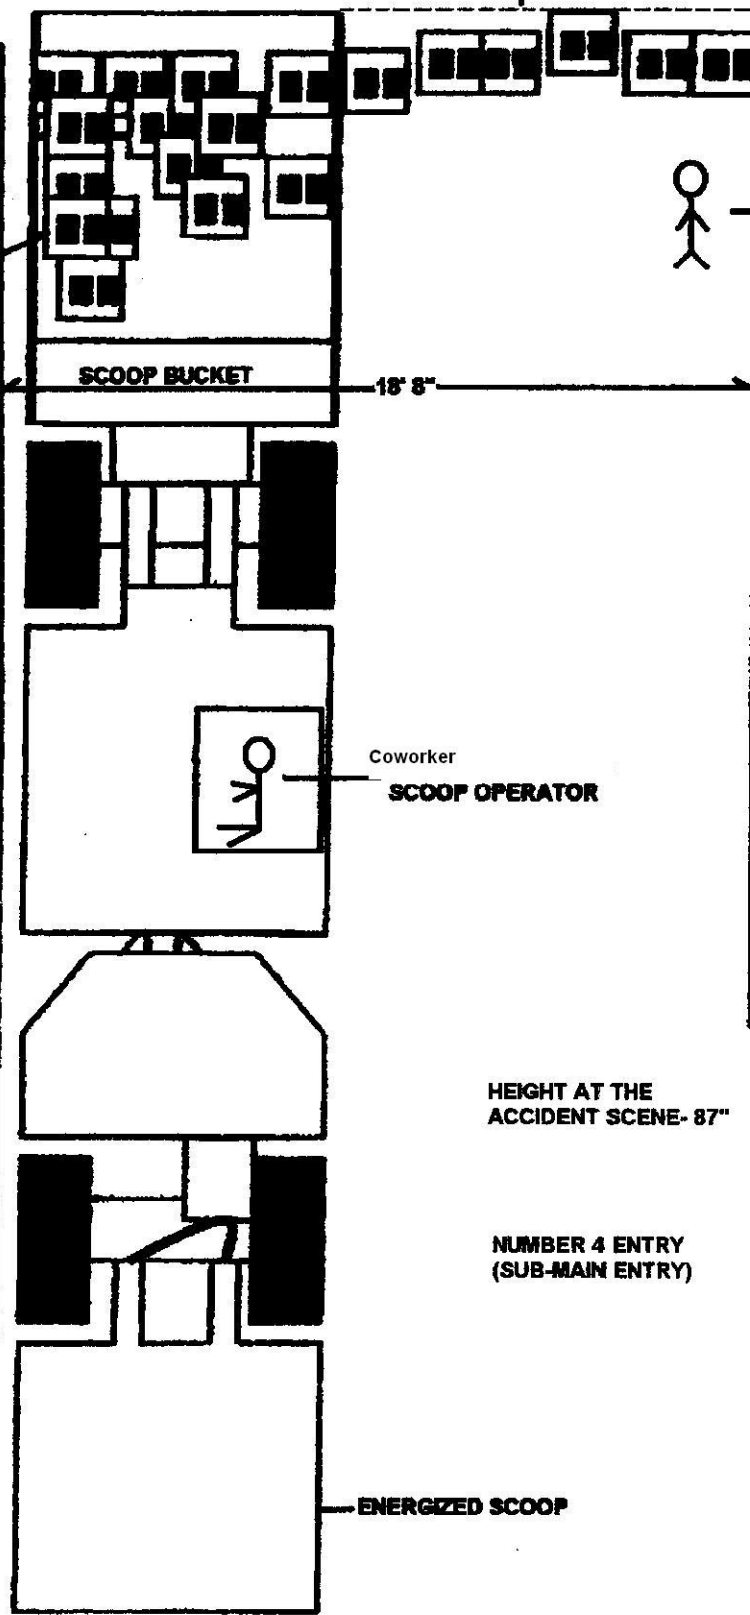
SKETCH NO. 1
BEFORE THE
ACCIDENT

THIS SIDE OF THE
PERMANENT STOPPING WAS
PUSHED OUT FIRST

CONCRETE BLOCKS
THAT WERE PUSHED
OUT FROM THE
PERMANENT
STOPPING BY THE
SCOOP

HEIGHT AT THE
ACCIDENT SCENE- 87"
